GASBUGGY

GASBUGGY PRELIMINARY POSTSHOT
SUMMARY REPORT

Fred Holzer

Lawrence Radiation Laboratory
Livermore, California

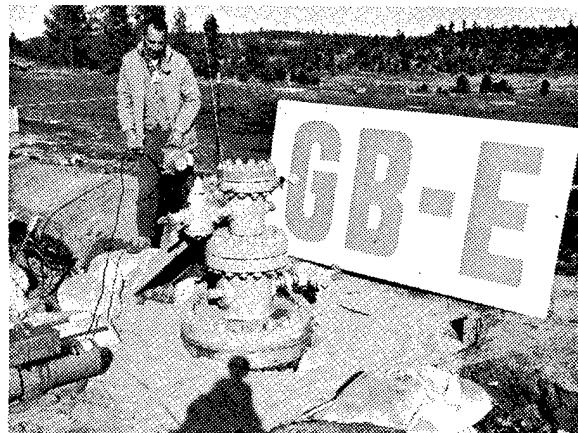
On the leveled area on the ground above the explosion, very little evidence of any surface disturbance was visible. Figures 1 and 2 show the GB-E and GB-1 well-head installations as they appeared immediately after reentry. A few minor cracks in the dirt access road were soon obliterated by traffic. A cable reel left some 300 ft from the GB-E well head suffered a bent axle, and there was some minor damage to electronic equipment at the recording trailer park and at the control point.

Fig. 1. GB-E well-head installation immediately after reentry, about 3 hr after shot time. The area is being checked for the presence of gaseous radioactivity; none was found.
